Manhole Inspection Summary

Manhole # S19A1_002MH

Inspection ☐ Is Incomplete Rating: **3) Fair**

Location Address: **2000 whistler av**

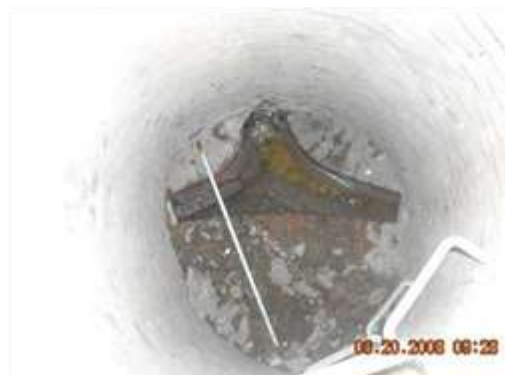
Top View

hole in patch repair

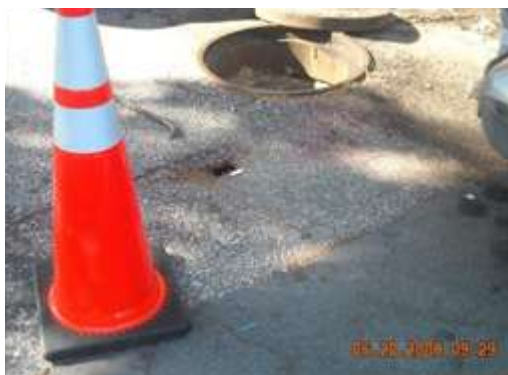
Comments **cracks and settlement of asphalt and curb, as well as a hole in the asphalt patch around manhole structure.**

evidence of subgrade failure

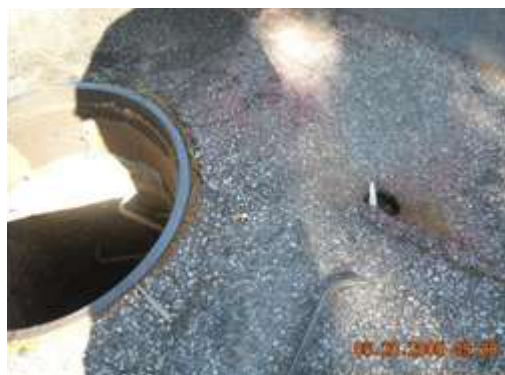
Misc

hole in patch area around manhole

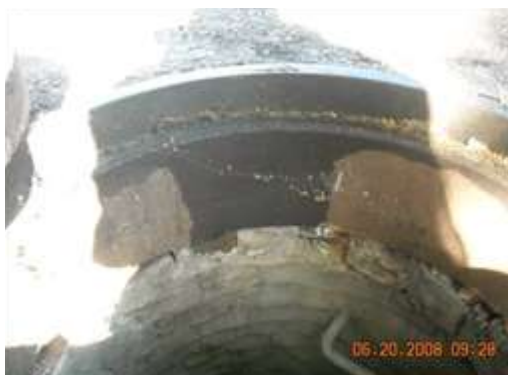
Defect 4

Subject To Ponding: **Ponding**

inflow evidence from ponding

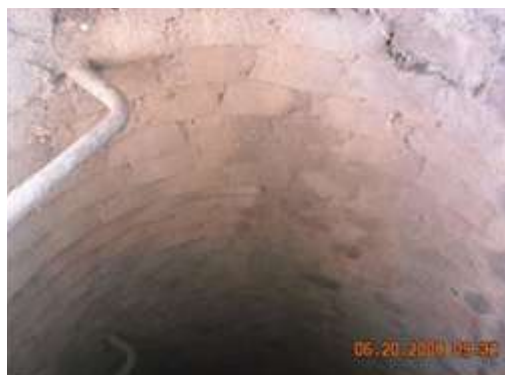
Defect 3

Condition: ☐ Sound ☒ **Cracked** ☐ Root Intrusion ☐ Loose Brick ☐ Deteriorated

Infiltration: ☐ None ☐ Joint ☐ Cracks ☐ Mortar ☐ Roots ☒ **Wall**

infiltration evidence @ corbel wall

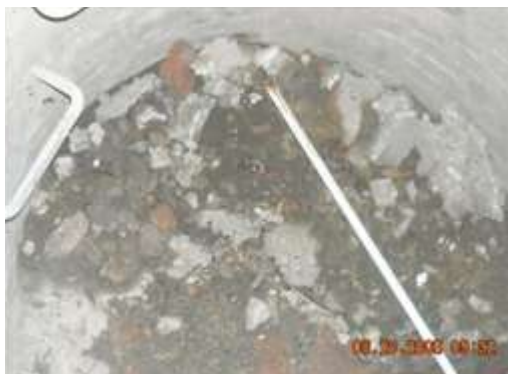
Defect 2

Condition: ☐ Sound ☐ Cracked ☐ Root Intrusion ☐ Deteriorated ☐ Leaks ☒ **Debris**

debris on bench

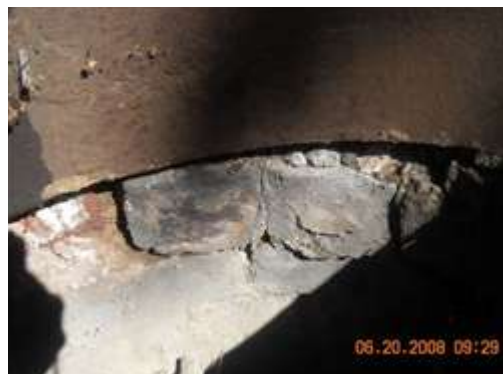
Condition: ☐ Sound ☒ **Cracked** ☐ Root Intrusion ☐ Loose Brick ☐ Deteriorated

cracked chimney brick

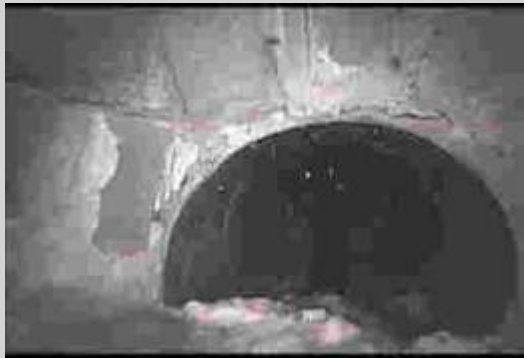
12 O'Clock Outflow

8 in. Circular Gravity Sewer
Pipe Out @ 12 O'Clock

Pipe Height: **8.4** (in.) Rod and Bar (Angled)
Pipe Material: **Clay** ☐ Pipe Lined
Invert Depth: **8.19** (ft.) Flow Characteristics: **Slow**
Deposits: ☐ None ☐ Mud ☒ **Sludge** ☐ Debris ☐ Grease
Silt Depth: **3** (in.) Deposits Extent: **Medium**
Infiltration: **None** Pipe Seal Cond: **Sound**

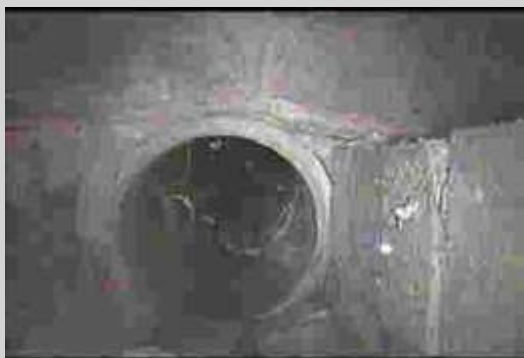
3 O'Clock Inflow

6 in. Circular Gravity Sewer
Pipe In @ 3 O'Clock

Pipe Height: **6** (in.) Rod and Bar (Angled)
Pipe Material: **Clay** ☐ Pipe Lined
Invert Depth: **7.94** (ft.) Flow Characteristics: **Slow**
Deposits: ☒ None ☐ Mud ☐ Sludge ☐ Debris ☐ Grease
Silt Depth: **0** (in.) Deposits Extent:
Infiltration: **None** Pipe Seal Cond: **Sound**

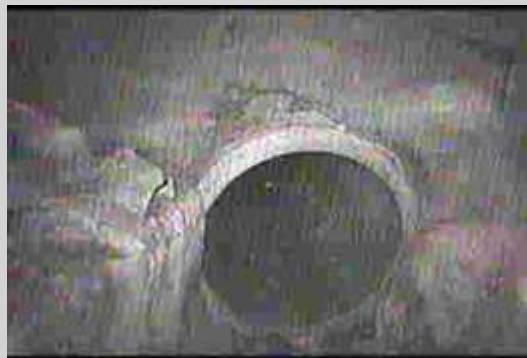
9 O'Clock Inflow

6 in. Circular Gravity Sewer
Pipe In @ 9 O'Clock

Infiltration: **Evidence**

Pipe Seal Cond: **Cracked**
